# **STAC Alert**

Alert Reference #: SA-0001

### Hazard: Corroded Guy Wire with Fibre Core

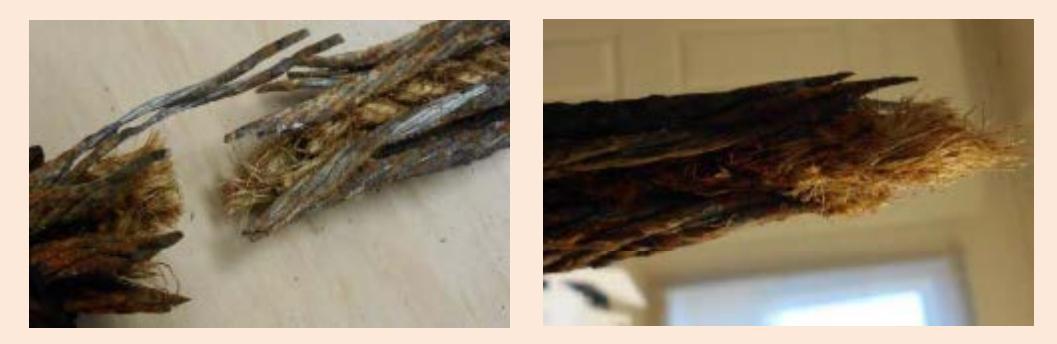
A Canadian carrier recently discovered a hazardous situation related to FIBRE CORE GUY LINES with excessive corrosion and potential breakage. These guy cables can be found on older sites that were constructed in the 1970's or earlier.

Severely corroded and broken wire rope fibre core guy

- 1. **DO NOT CLIMB** any guyed tower until you perform an inspection of the guy lines to determine if it is Fibre Core. See procedure
- 2. If the site is a Fibre Core Guyed Tower, suspend all work and DO NOT CLIMB. Report all sites with fibre core guy lines to your carrier rep or construction project manager immediately.
- 3. If the site is not a Fibre Core guyed tower, work may proceed.

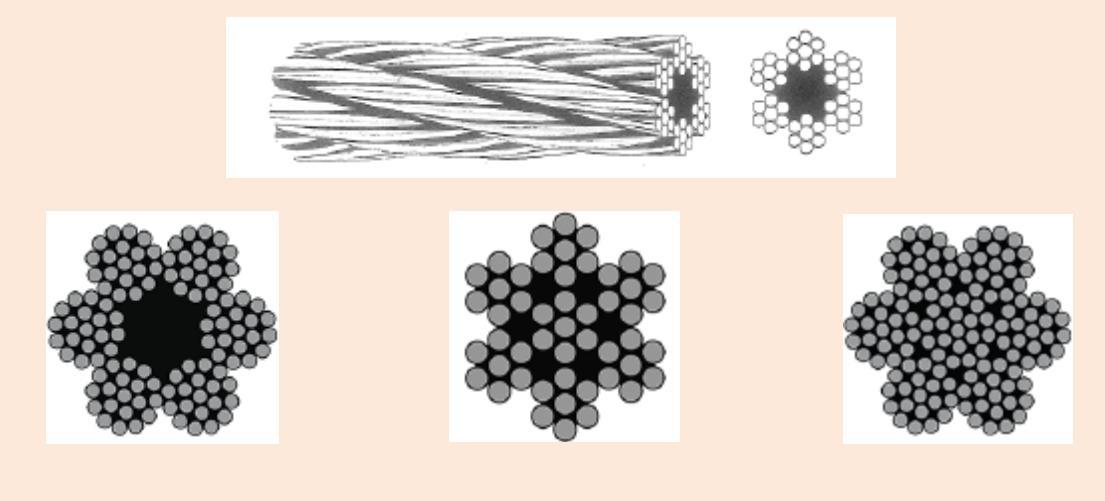
The first visual clue in identifying wire rope is that it will have many more strands than a typical guy strand or bridge strand. Wire rope will have strands that are made up of additional smaller individual strands. This is illustrated below where you can see the outside of the wire rope guy and a cross section of the inside where multiple distinct bundles of stands are observed:

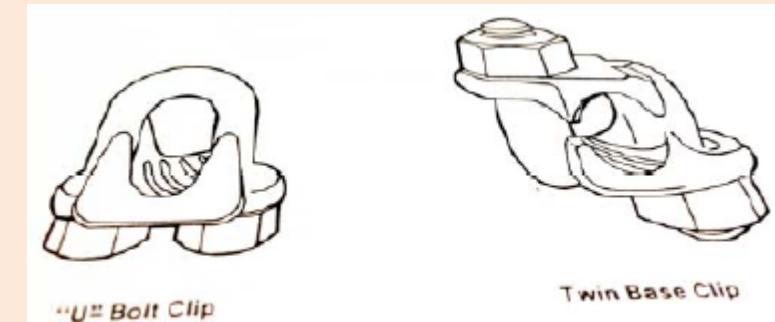
The second visual clue to identify wire rope guys is that they will be terminated at the anchors with either twin based u-bolt clips (Crosby clips) or fist grips. Wire rope guys may be terminated on the tower end with a factory swaged mechanical connection, but this may not be visible from the ground and is not necessarily a distinguishing feature of wire rope guys. Wire rope guys do not use preforms. An illustration of the two types of termination hardware on wire rope guys is shown below:

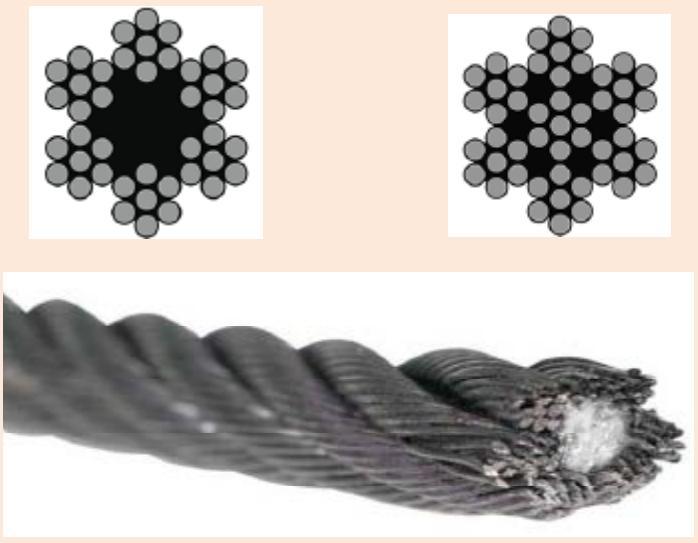
If you compare the two cross sections of wire rope illustrated below, the one on the left is referred to as 6x7 FC for 6 bundles of 7 strands each with a fibre core. The cross section on the right shows the central void filled with an addition bundle of strands. This type of wire rope is referred to as 7x7 SC for 7 bundles of 7 strands with a wire rope core. You may also see this written on drawings as IWRC (inner wire rope core). When viewing either of these guys from the outside they will appear identical. The cross section has to be viewed to classify the core of the wire rope.

Fibre core wire rope in new condition

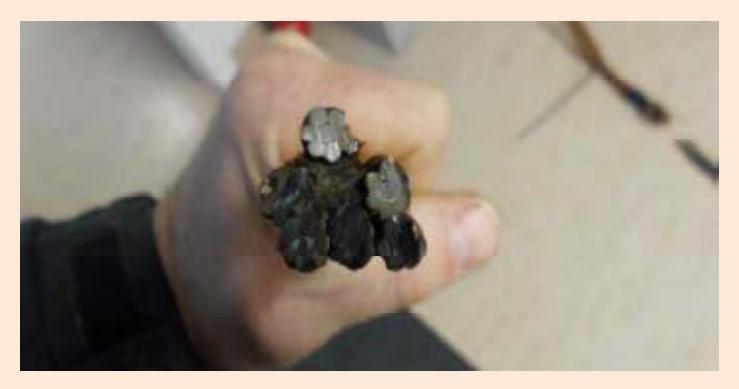
Due to the fact that these guy wires were installed in the seventies or earlier, the galvanized coating will very likely be breaking down and corrosion will be observed. The CSA S37 standard required wire rope guys to conform to CSA G4 which required them to be galvanized. The corrosion that is happening to the individual strands may or may not be obvious. A steel core wire rope has strands in the center that are not visible anywhere on the outside. The fiber core may be wicking moisture and may be accelerating corrosion on the inside of the wire rope. Pitting and corrosion may be obvious from the outside but this is not always the case. Wire rope can corrode from the inside out.

Note: Proximity of the structure to the ocean can make this situation worse.

Fibre core wire rope in very poor, corroded condition

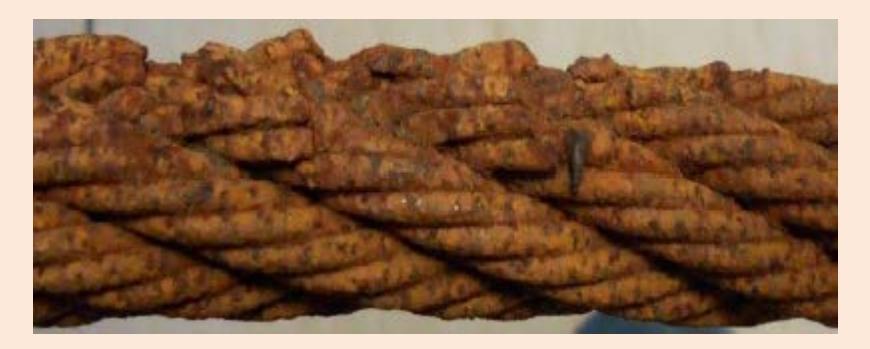
Wire rope fibre core with extensive corrosion, pitting, and broken strands visible on the exterior.

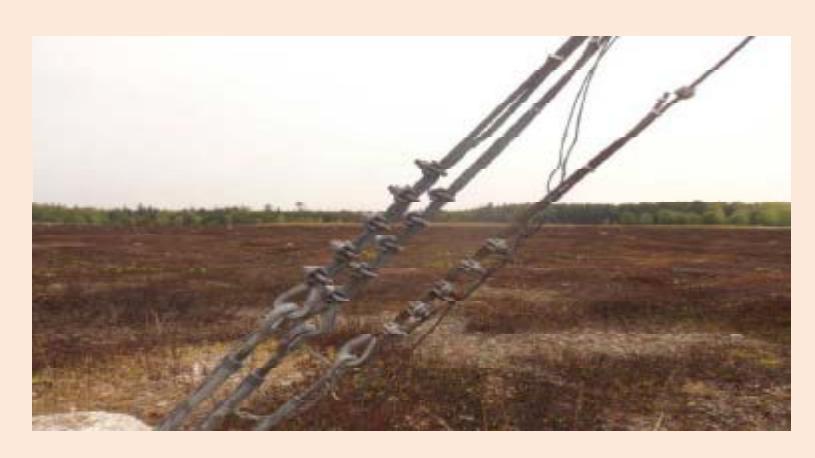
Wire rope guys terminated with clips at an anchor. Note the lower guys appear corroded but the upper guys show the galvanized coating mostly intact.

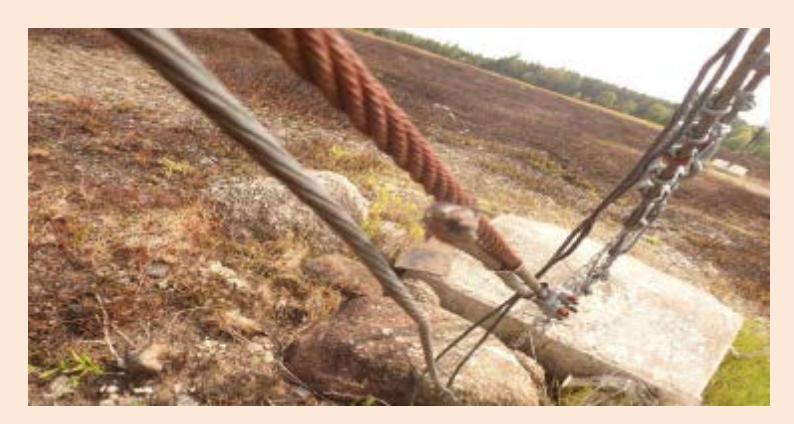
Wire rope fibre core with a corroding exterior surface and the fibre core visible in cross section at the termination.
